Subject Final RI Report Replacement Pages

Hi Chris - during preparation of Figures 7-2 through 7-4 of the Draft Feasibility Study (CDM, December 21, 2007), it became apparent that several of the Section 5 figures in the Final RI Report (CDM, November 14, 2007) had not been revised to incorporate final calculations presented in the final Human Health Risk Assessment Report (CDM, November 9, 2007).

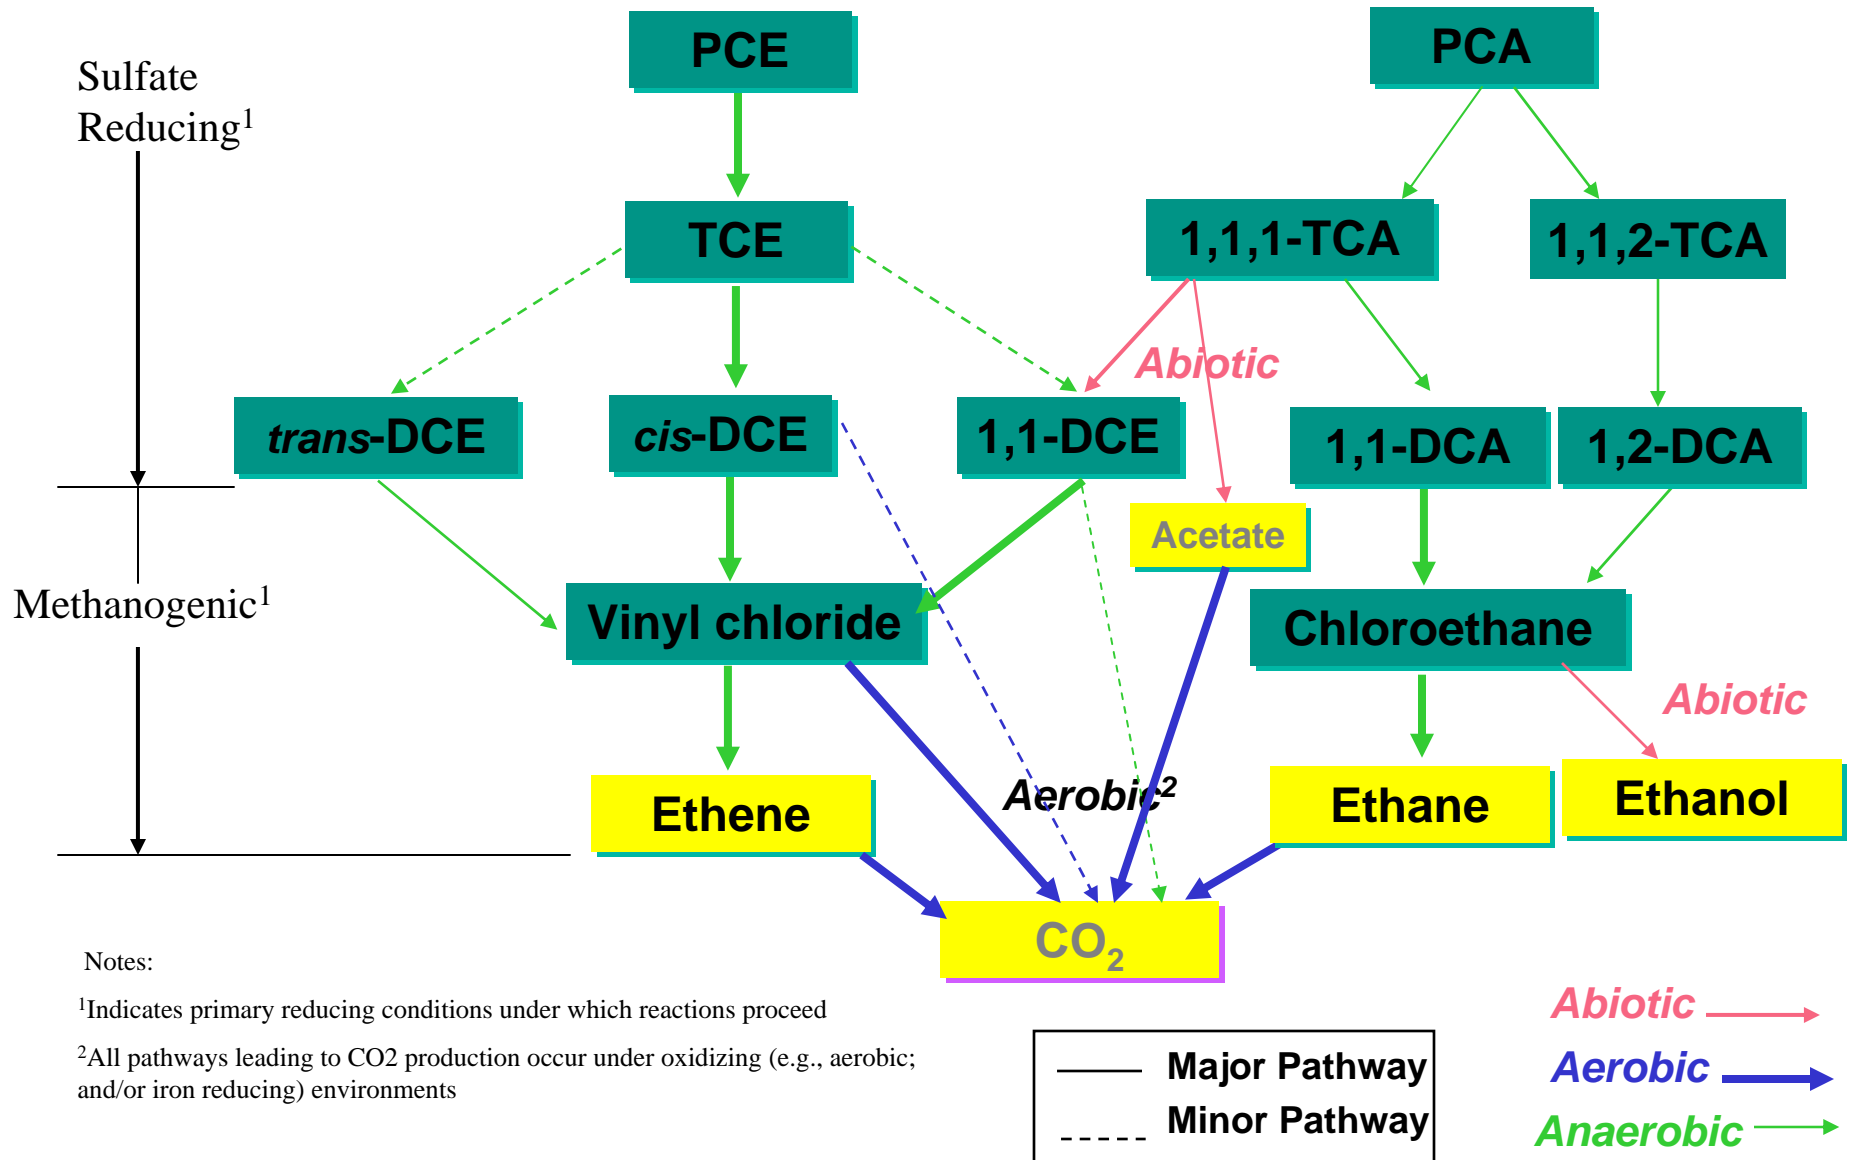
Figure 5-7 - Biotransformation Pathways for Chlorinated Compounds

A schematic pathway for the primary contaminants and their degradation products is shown in Figure 5-7. For PCE and TCE, reductive dechlorination could eventually result in the formation of ethene and ethane. However, incomplete reductive dechlorination could lead to the accumulation of intermediate toxic products (e.g., VC), although the lower chlorinated contaminants may subsequently degrade to innocuous carbon dioxide through oxidation processes.

TCA, an additional source contaminant present at the Site, is subject to abiotic transformations under aerobic and anaerobic conditions, and biological transformations under anaerobic conditions. TCA transformations and breakdown products are also summarized in Figure 5-7. The abiotic and biotic pathways are important to the ultimate fate of chloroethanes. In particular, 1,1,1-TCA may be transformed abiotically to form 1,1-DCE that can then undergo reductive dechlorination to form VC, and ultimately over time ethene and ethane. The frequent presence of 1,1-DCE in the subsurface is likely due, at least in part, to the abiotic degradation of 1,1,1-TCA.
